SPACE SHUTTLE AGING ELASTOMERS

Session: Space - Aging Orbiter

Cris Curtis

United Space Alliance – Space Systems Engineering
Orbiter Subsystem Area Manager

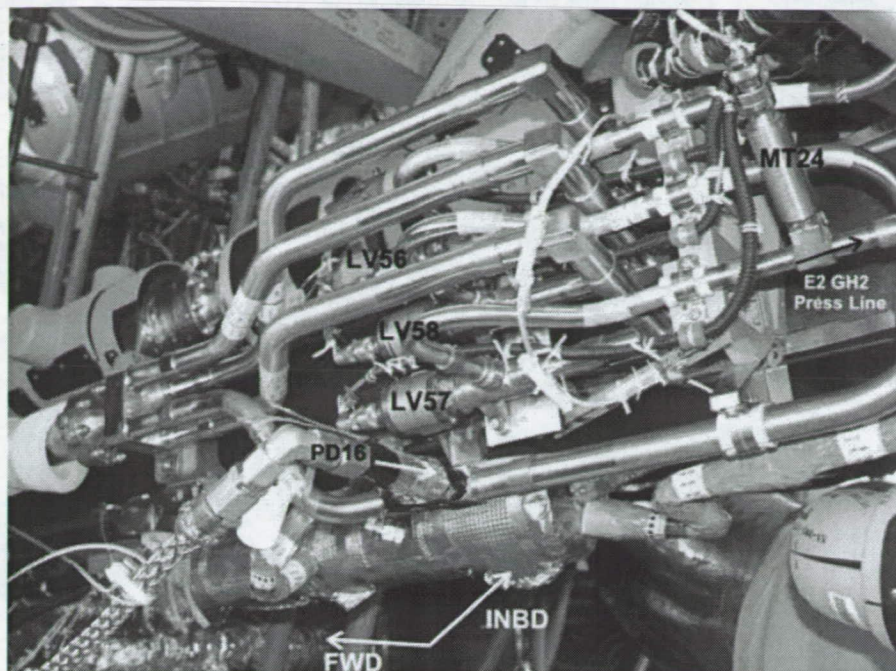
The remaining o-rings on the other two FCVs were also removed and replaced with new o-rings to insure no leakage and successful launch of Discovery. Atlantis and Endeavour had their FCV o-rings removed and replaced. FA investigation determined that 6 of the 9 o-rings from all three Orbiters contained cracks. The one that leaked and initiated the problem was the most severe. Additional FA work included laser dimensional, Shore A hardness and properties from a dynamic mechanical analyzer (DMA) and an Instron tensile machine. The FCV by design has a 9-mil (0.009 in.) gap that allows exposure of o-ring to ozone, air and elevated temperatures, accelerating the weathering process leading to cracking.

Figure 2: Installed GH2 Flow Control Valves

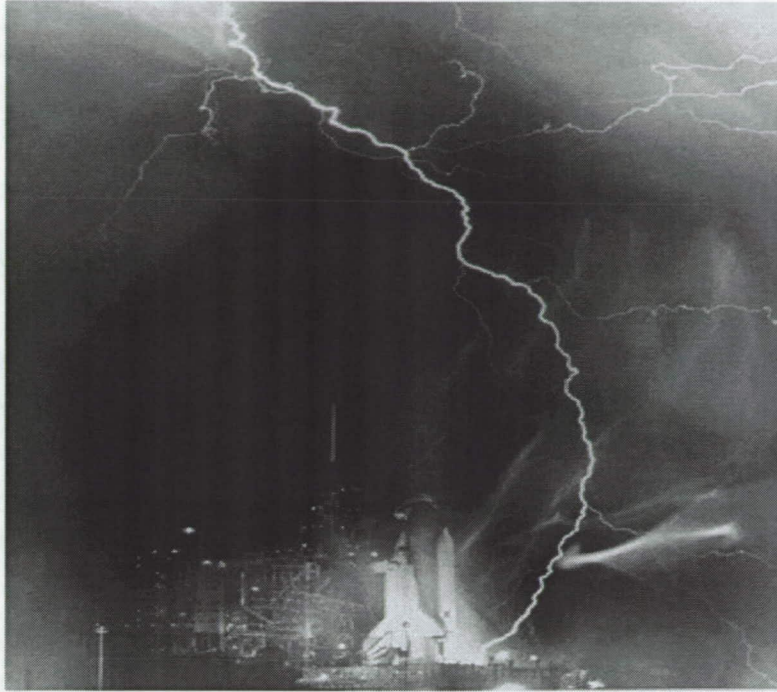
The failed o-ring also had white frosting discoloration providing more evidence that the radial cracks could be attributed to ozone attack. These o-rings are exposed to dry purged air the majority of their post installed static environmental life. The purged air is provided with electrical motors and frequent lightning strikes increase the normal ozone levels.

Figure 4: Lightning strike at launch pad during normal thunderstorms
